Naval Research Laboratory

NRL/MR/6180-92-7145

## Findings of Portable Air Mover Tests on the ex-USS SHADWELL

September 30, 1992

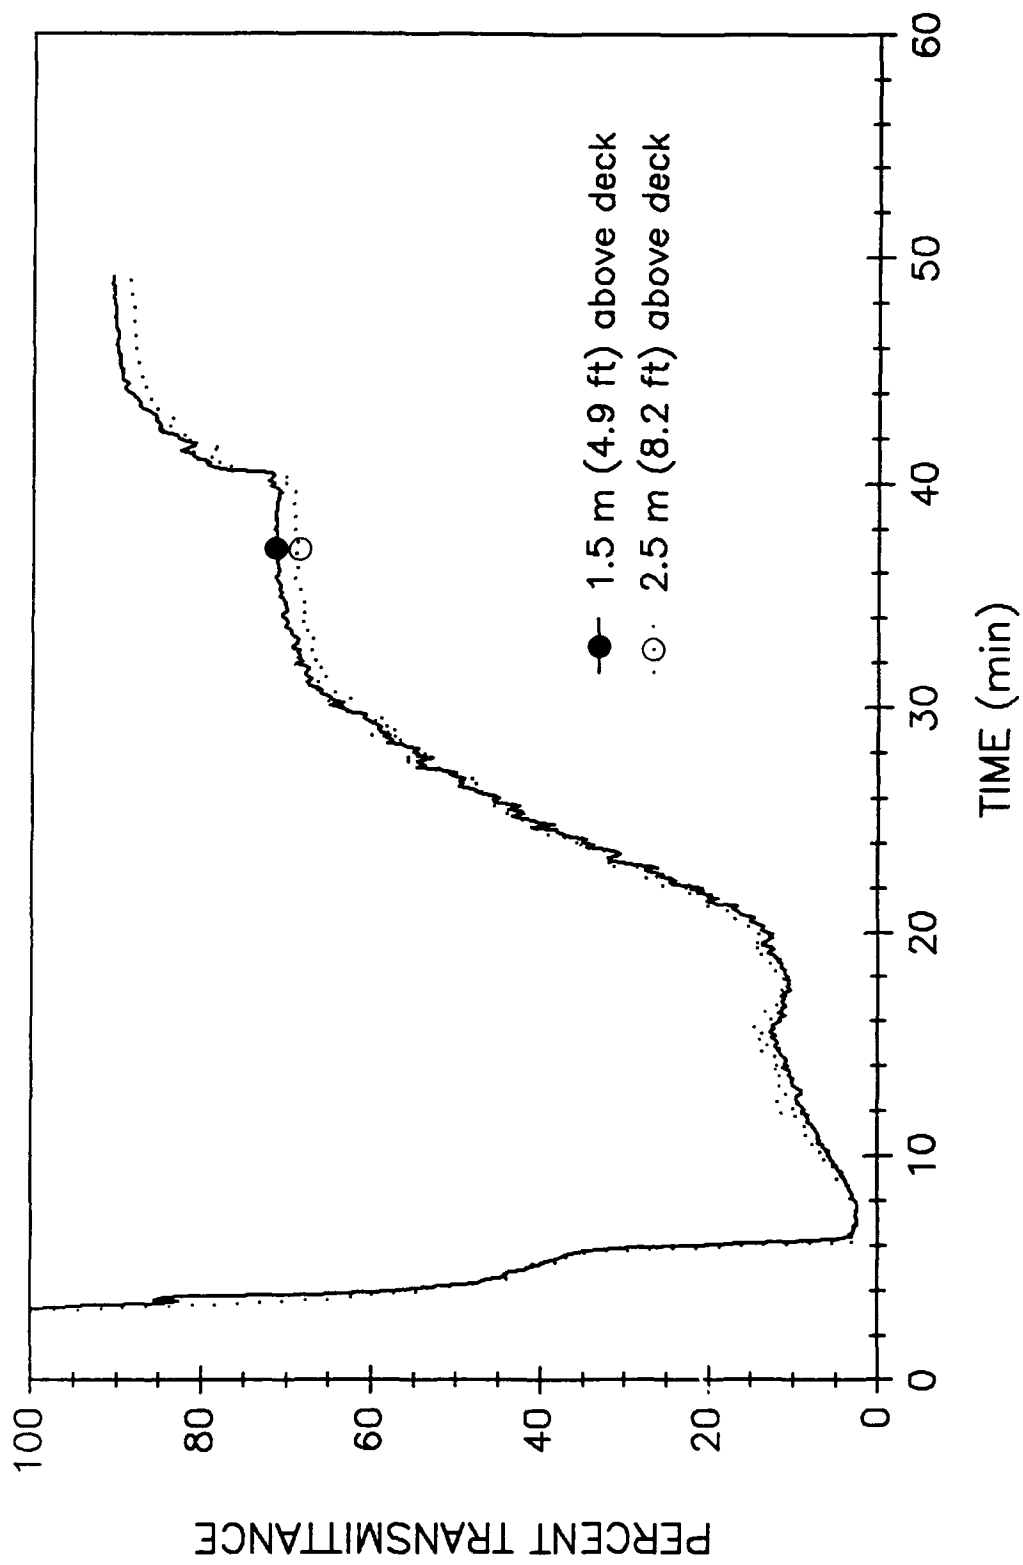
Fig. 87 - Percent transmittance in RICER 1 during FAN\_35  
using natural smoke venting

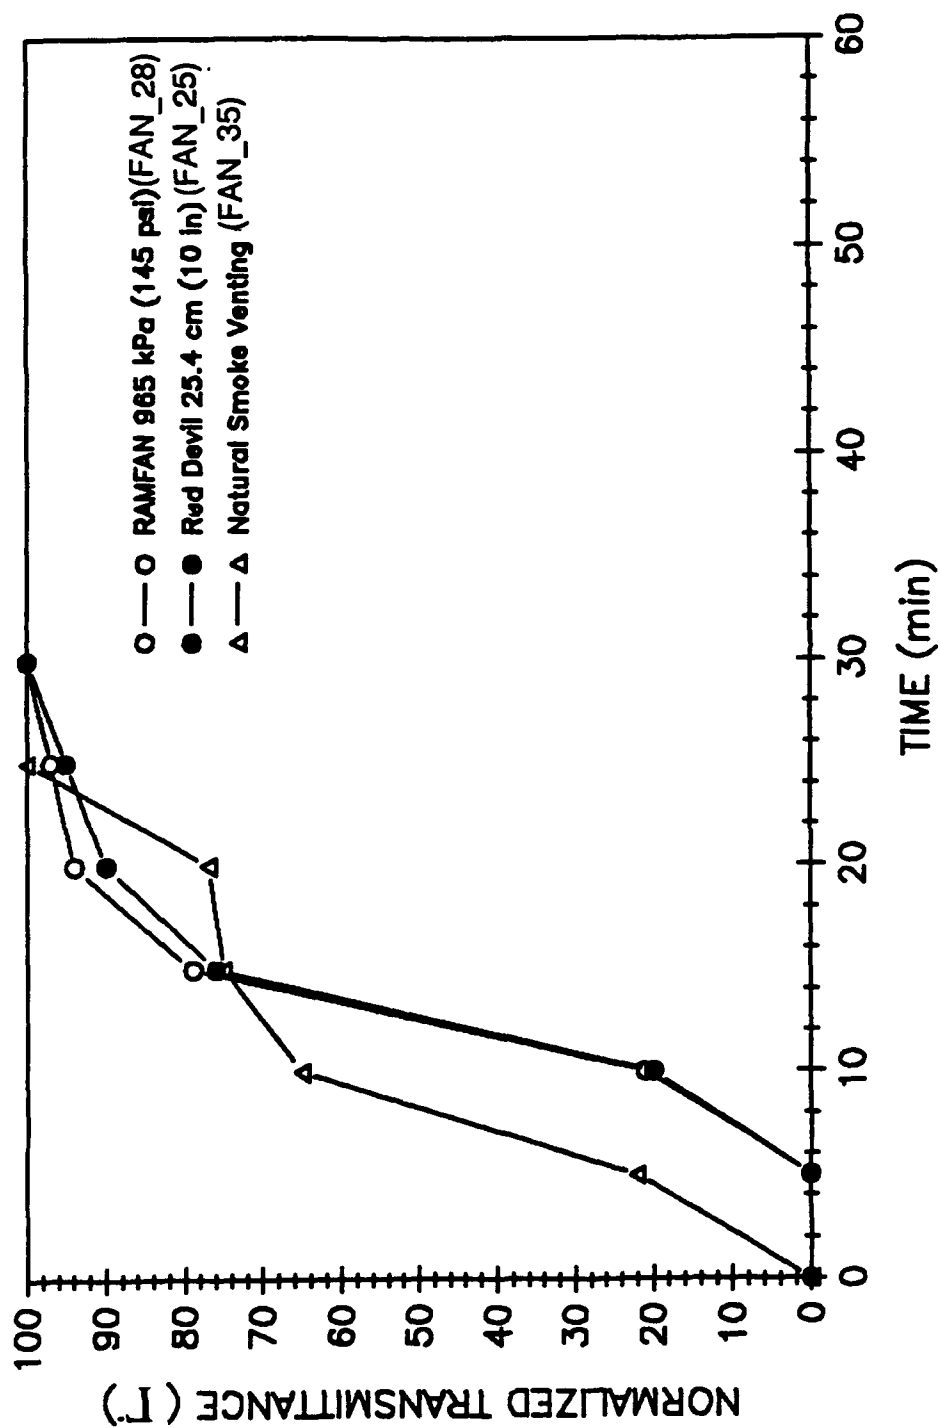
Fig. 88 - Recovery of normalized transmittance at 2nd deck - 2.5 m level after fan is activated

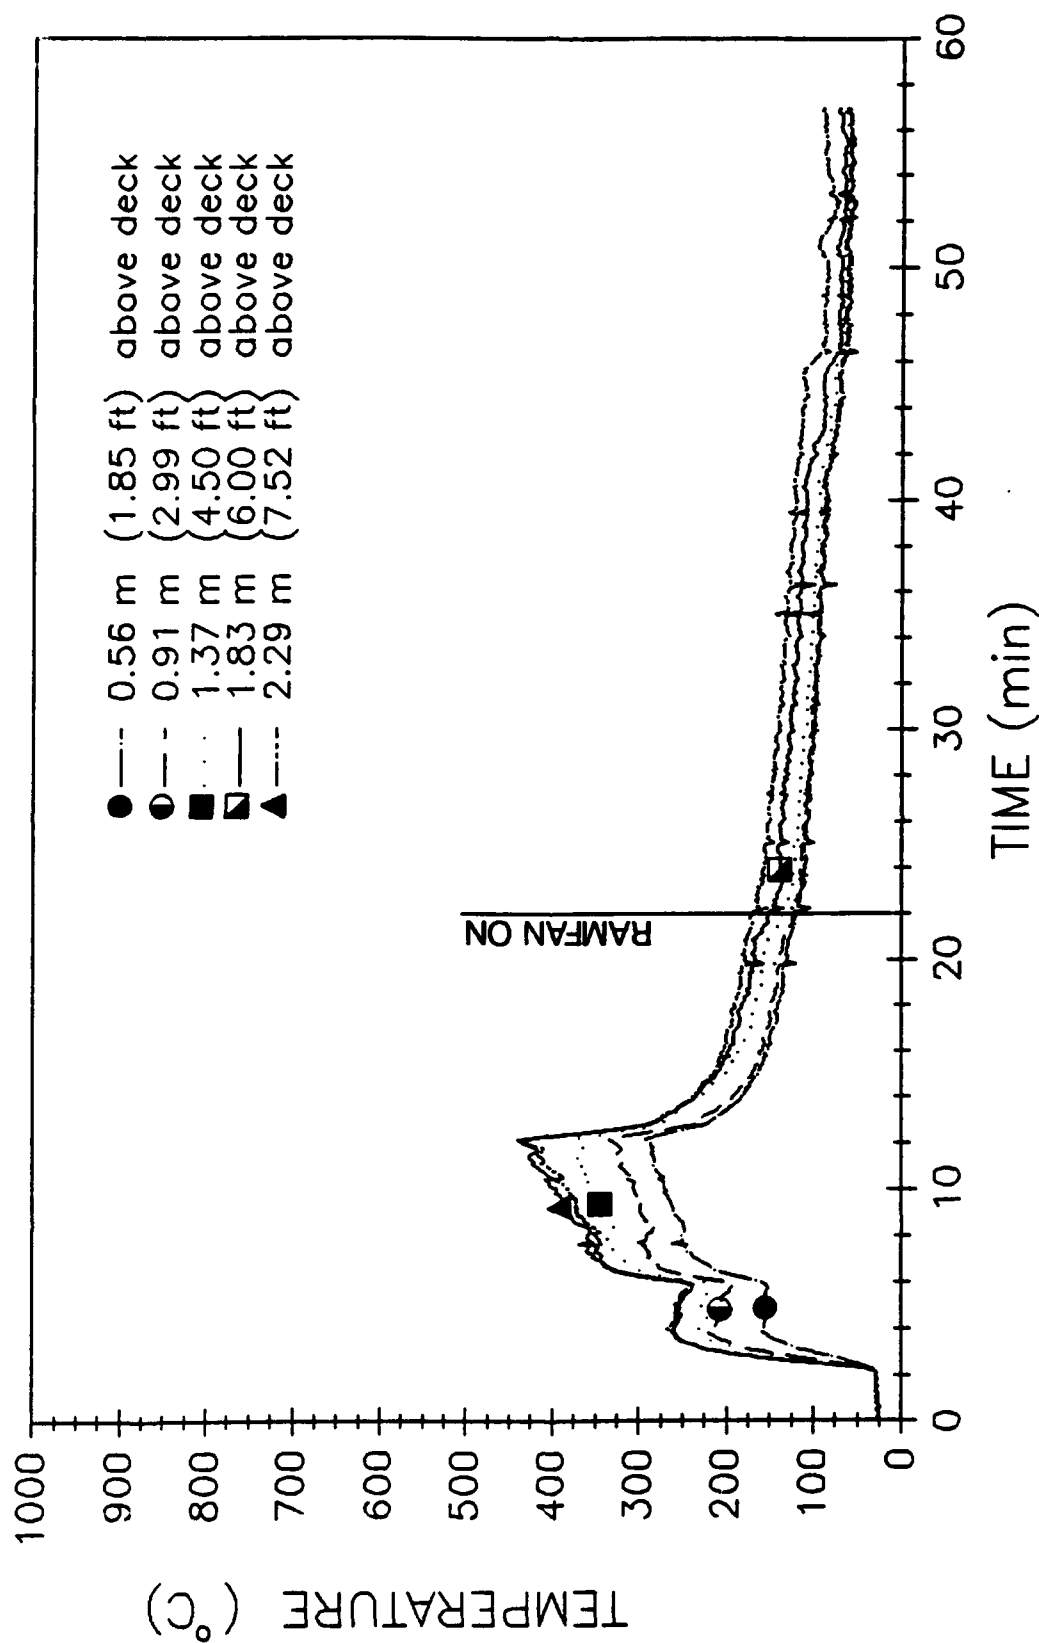
Fig. 90 - Temperature in BERTHING 2 (3-83-6) during FAN\_24 using RAMFAN at 965 kPa (144 psi)

The WMF with the integral spray feature appears to have the potential for being an effective tool for gaining access to hot compartments. As seen in Fig. 92, the temperatures decreased rapidly when compared to Fig. 90. Not only were the

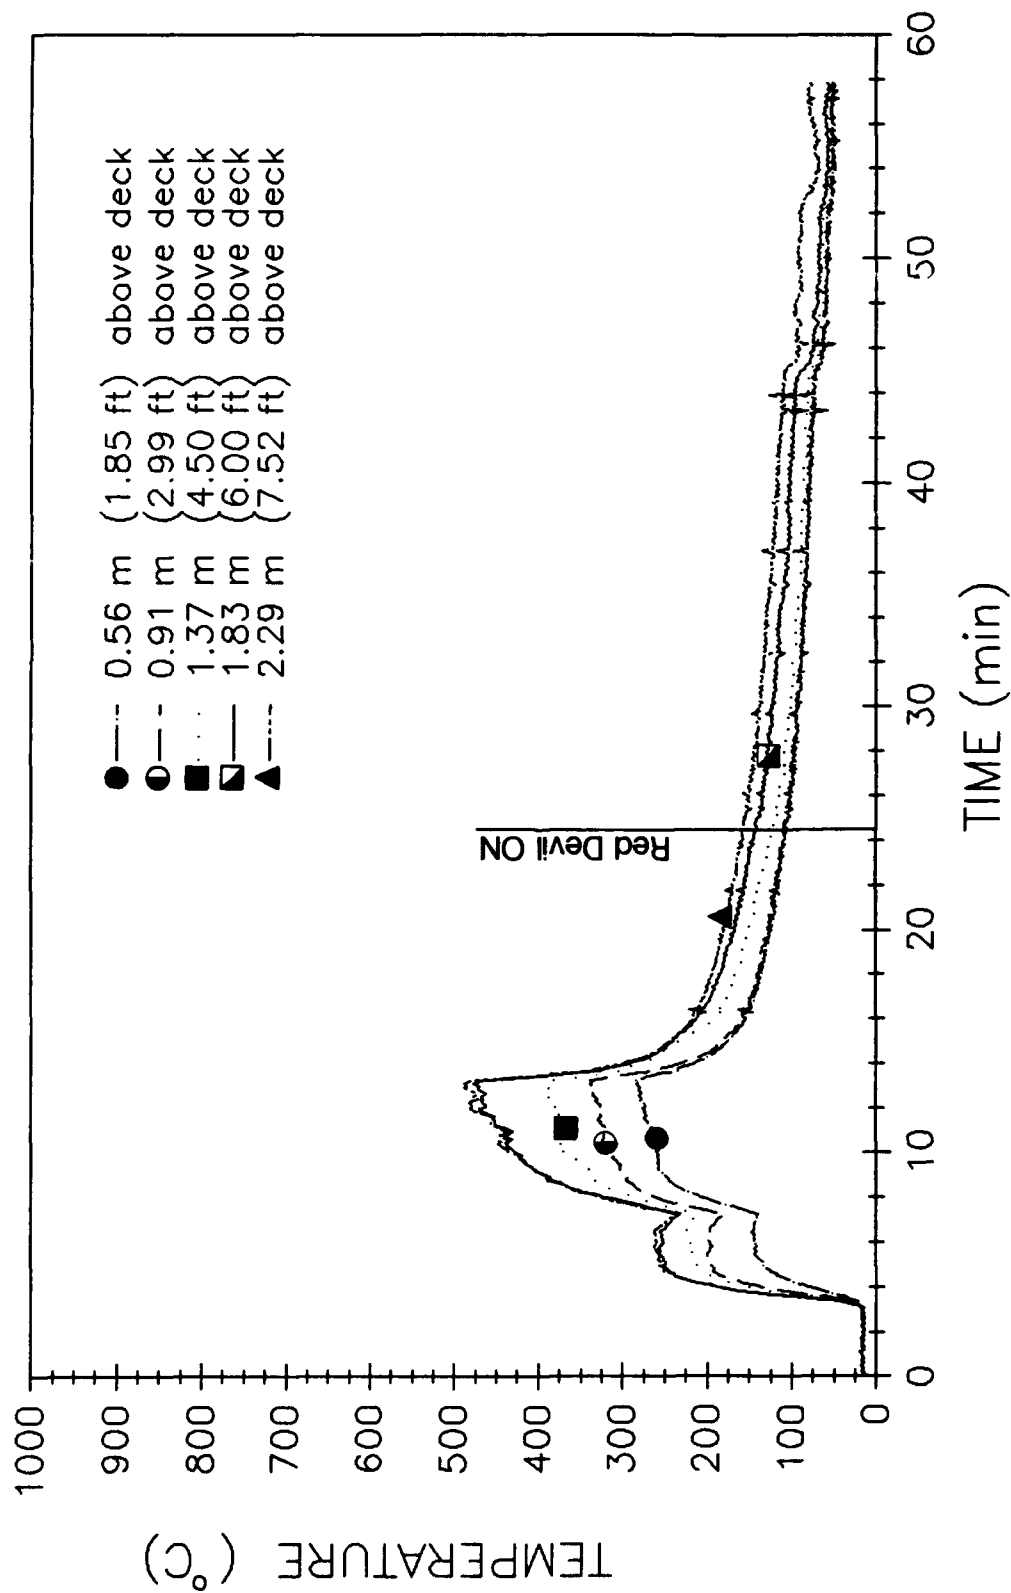
Fig. 91 - Temperature in BERTHING 2 (3-83-6) during FAN\_25  
using Red Devil 25.4 cm (10 in) duct

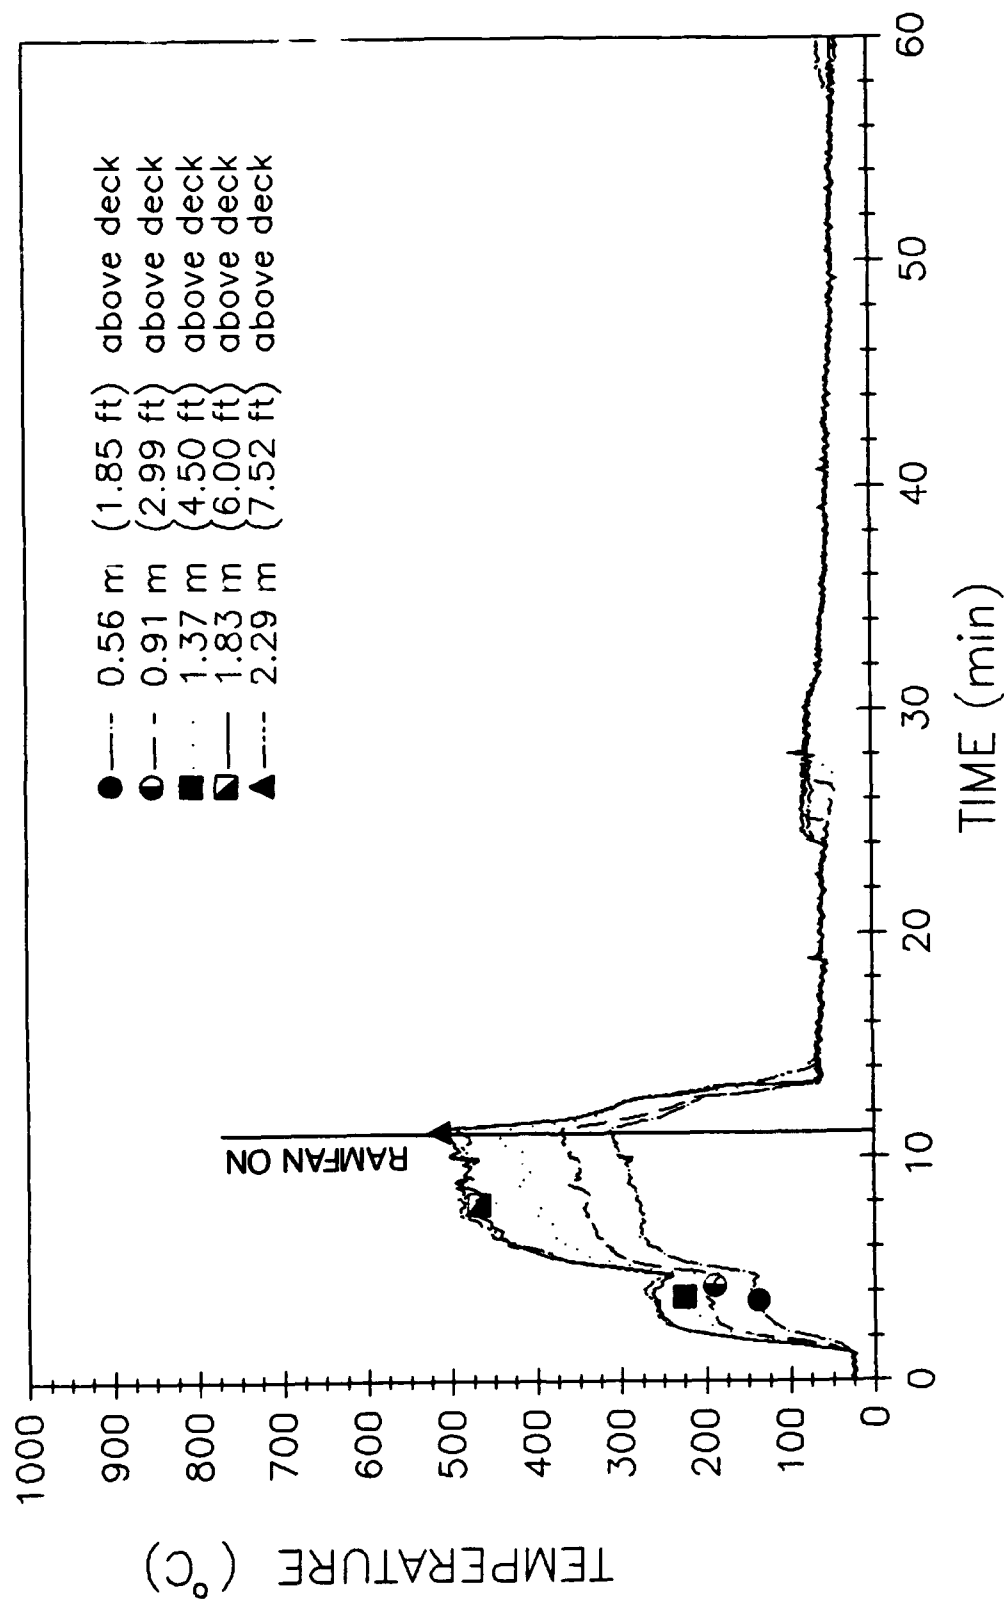
Fig. 92 - Temperature in BERTHINC. 2 (3-83-6) during FAN\_26 using RAMFAN 965 kPa (140 psi) with water mister

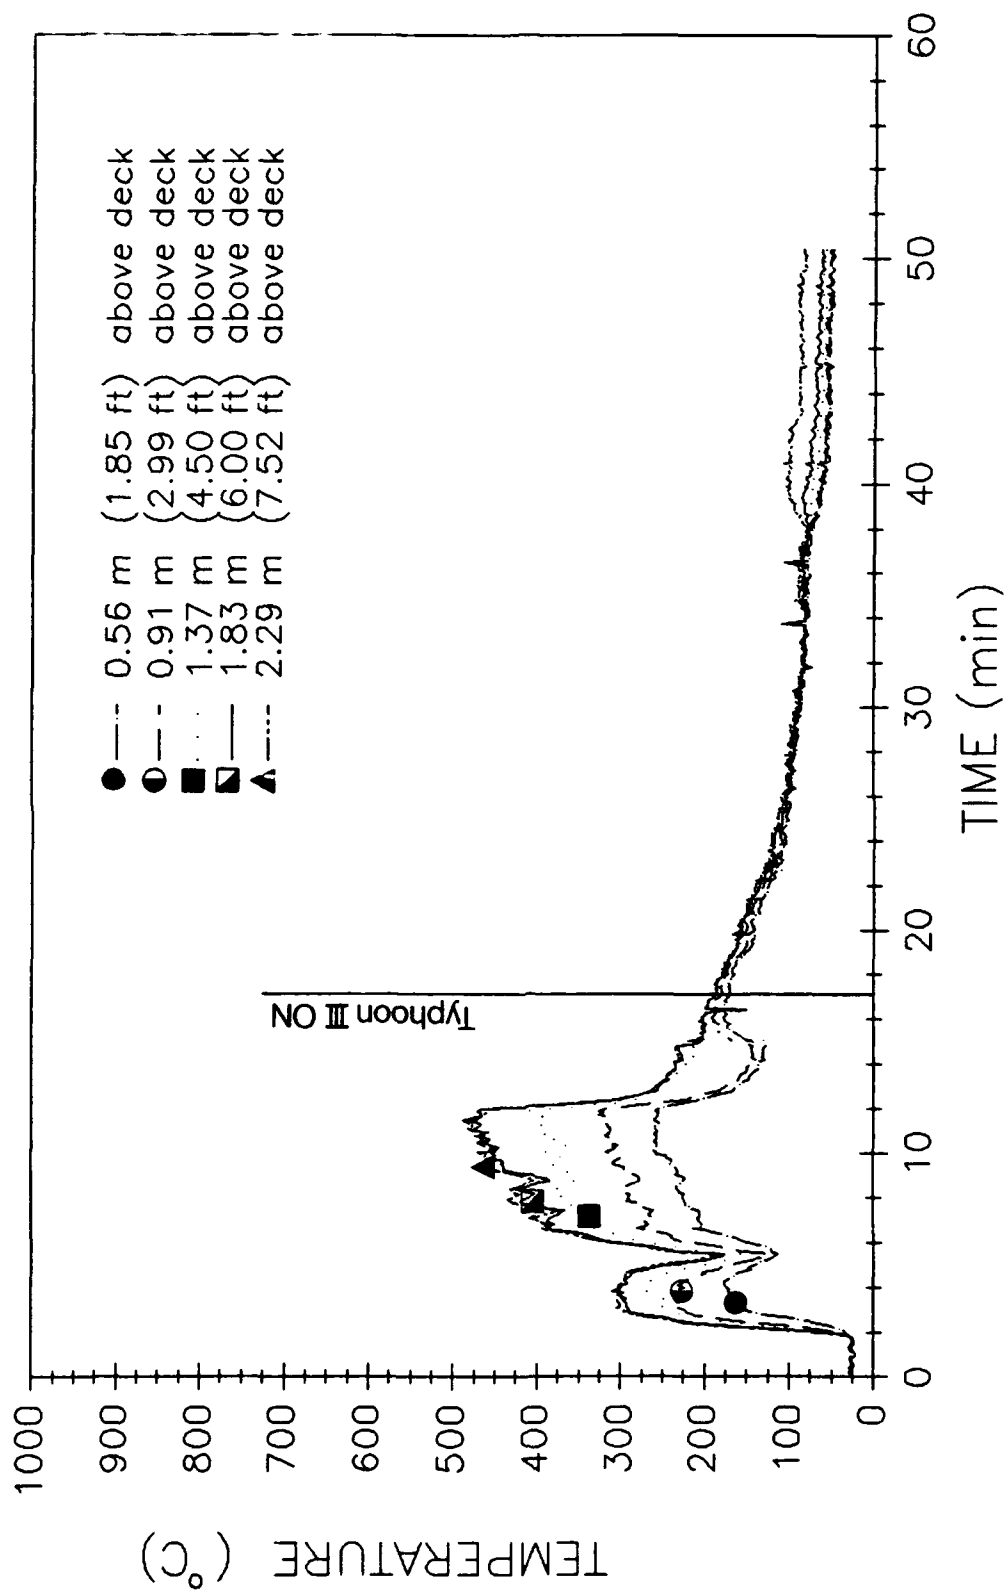
Fig. 93 - Temperature in BERTHING 2 (3-83-6) during FAN\_27

Figure 93 shows the decrease in compartment air temperatures when the Hale Typhoon III fan was used. Temperatures in the compartment were decreased; however, the rate of decrease is not as dramatic as the RAMFAN.

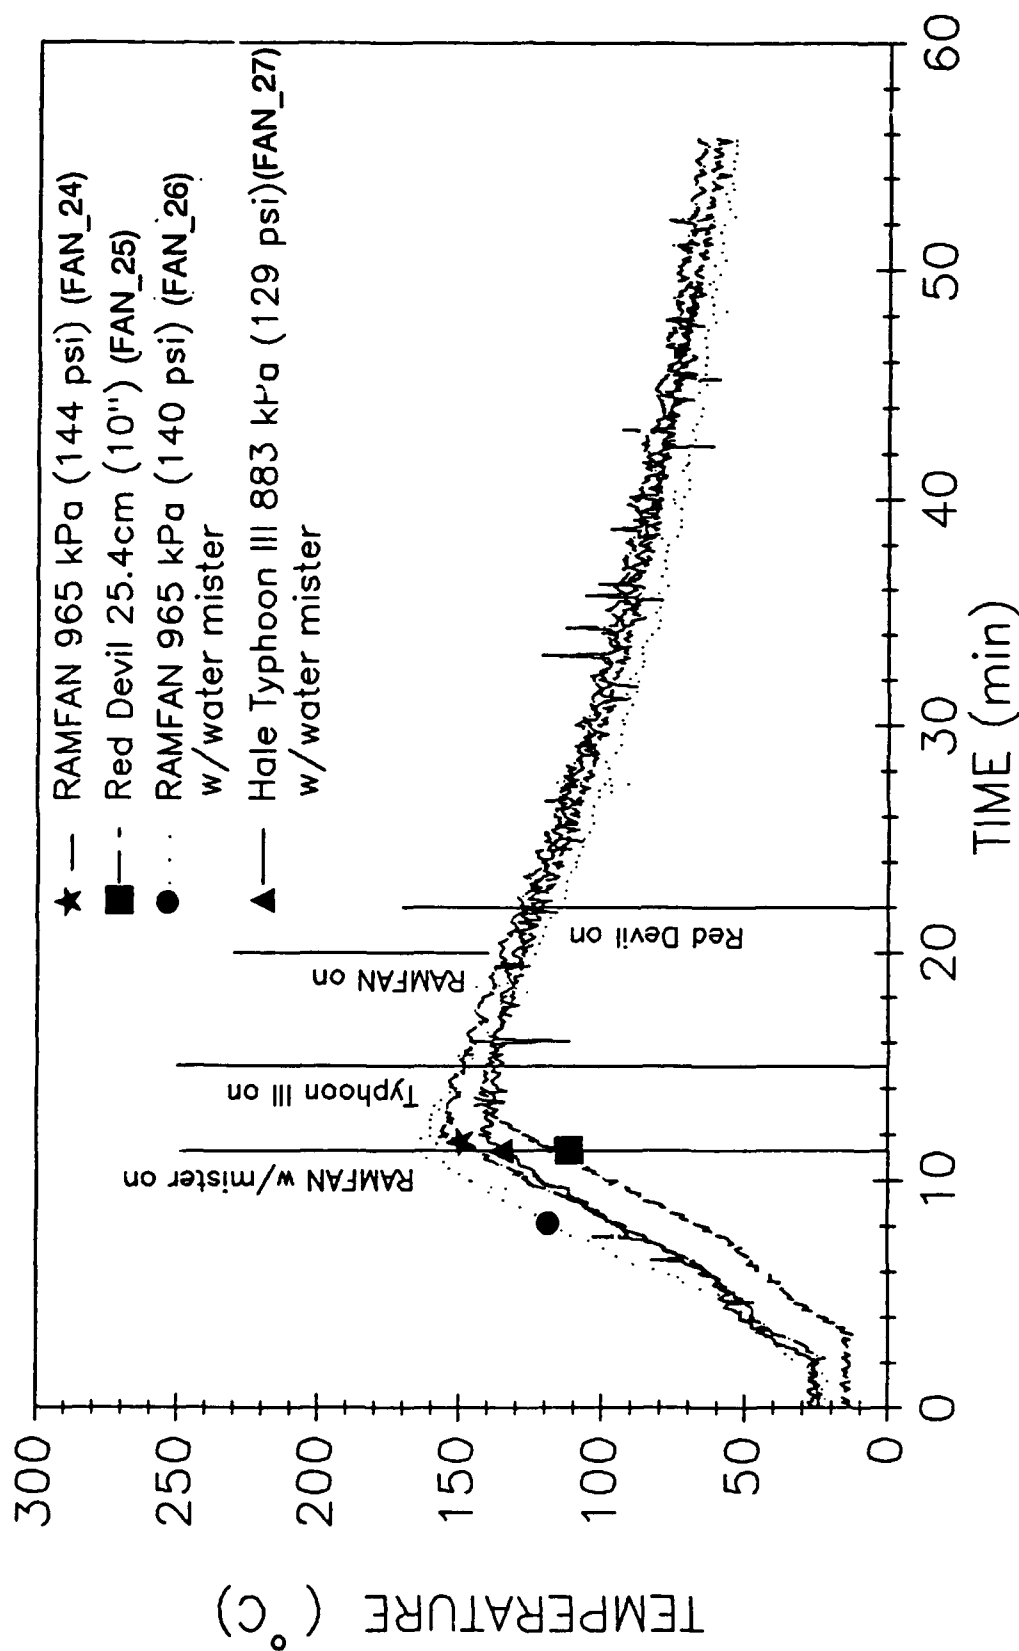
Fig. 94 - Average bulkhead temperatures in BERTHING 2 (3-88-2)

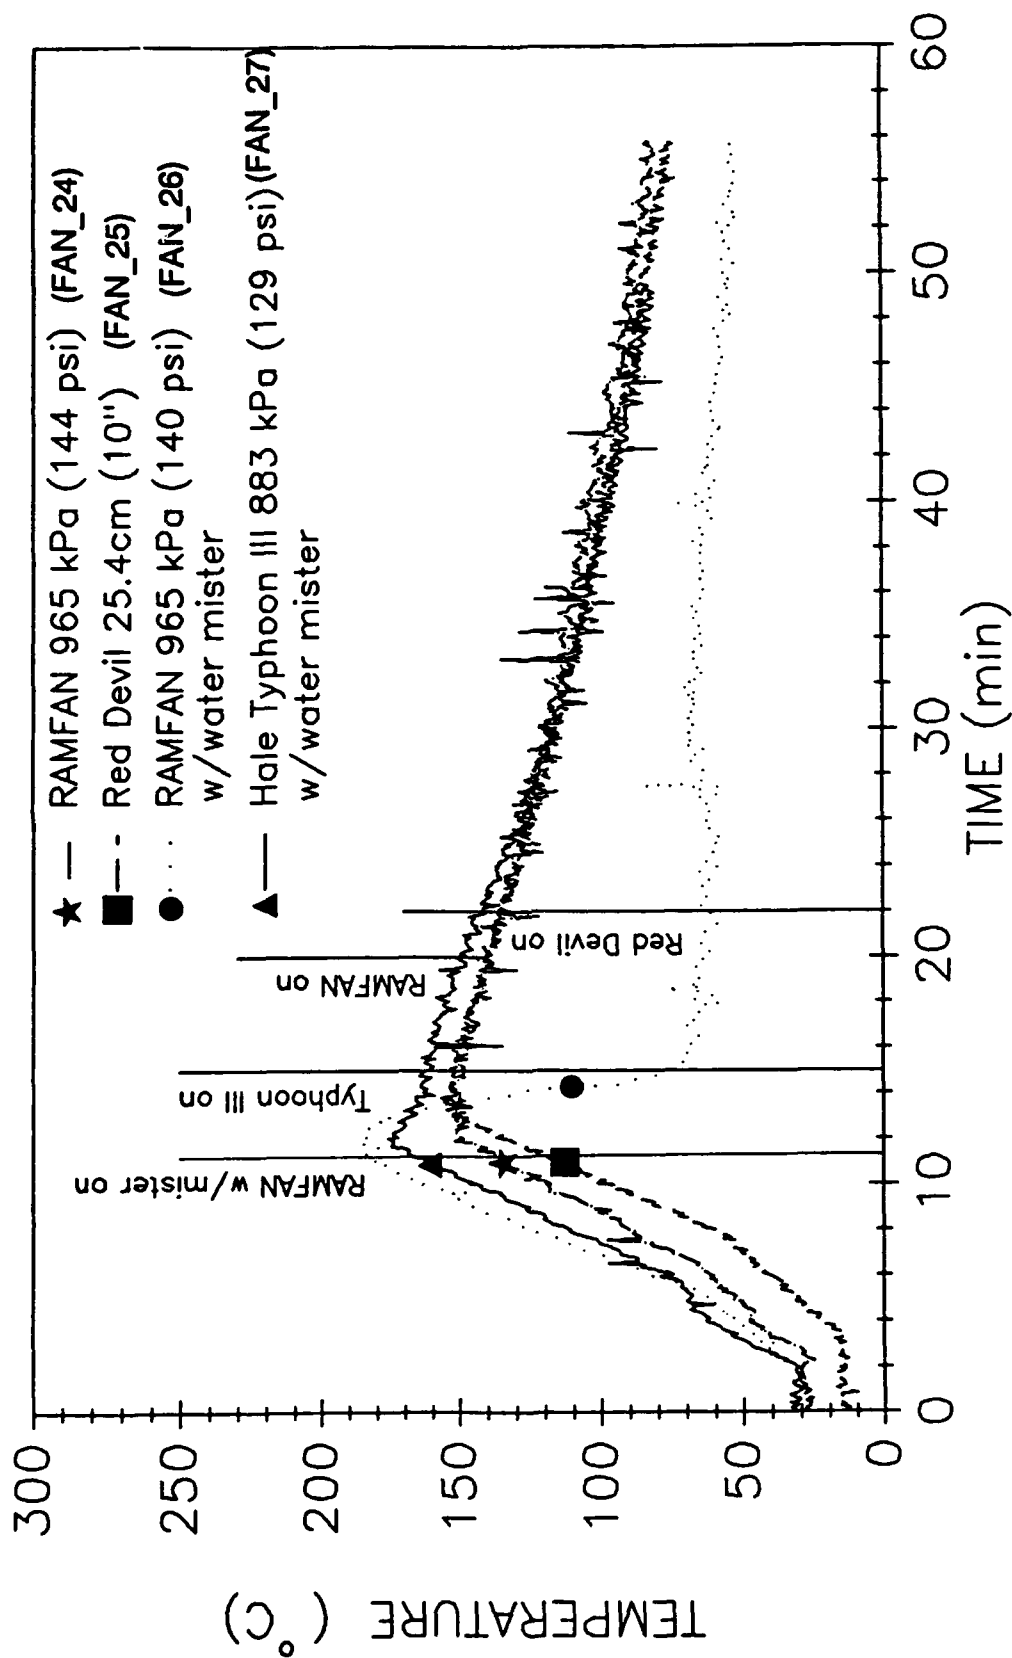
Fig. 95 - Average bulkhead temperatures in BERTHING 2 (3-81-2)

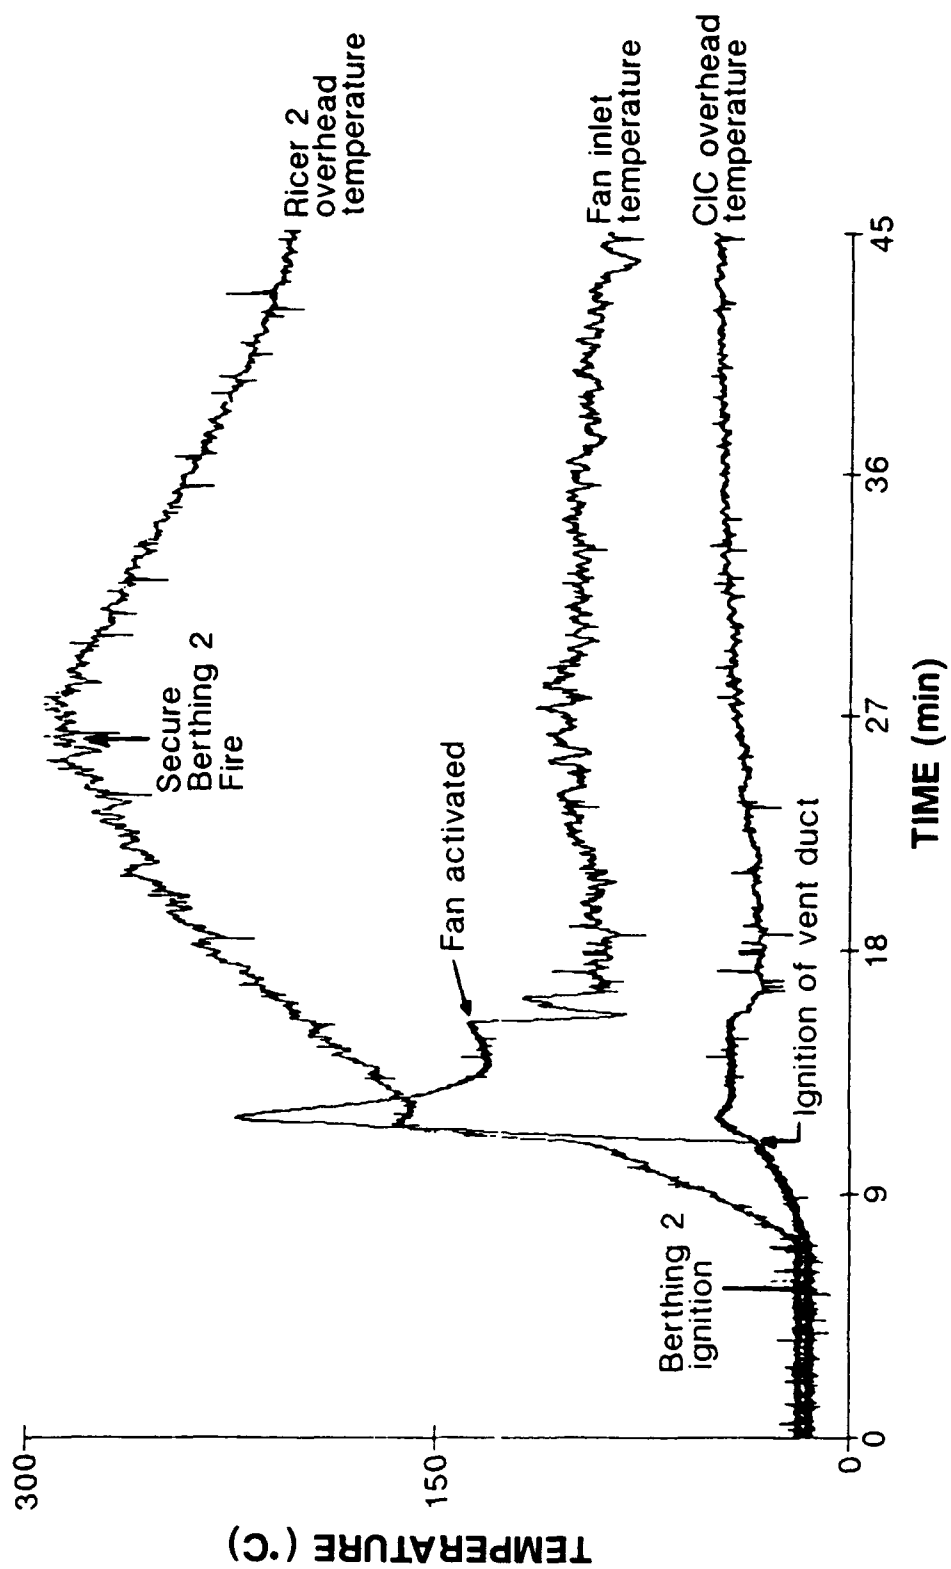
Fig. 98 - Heat stress test

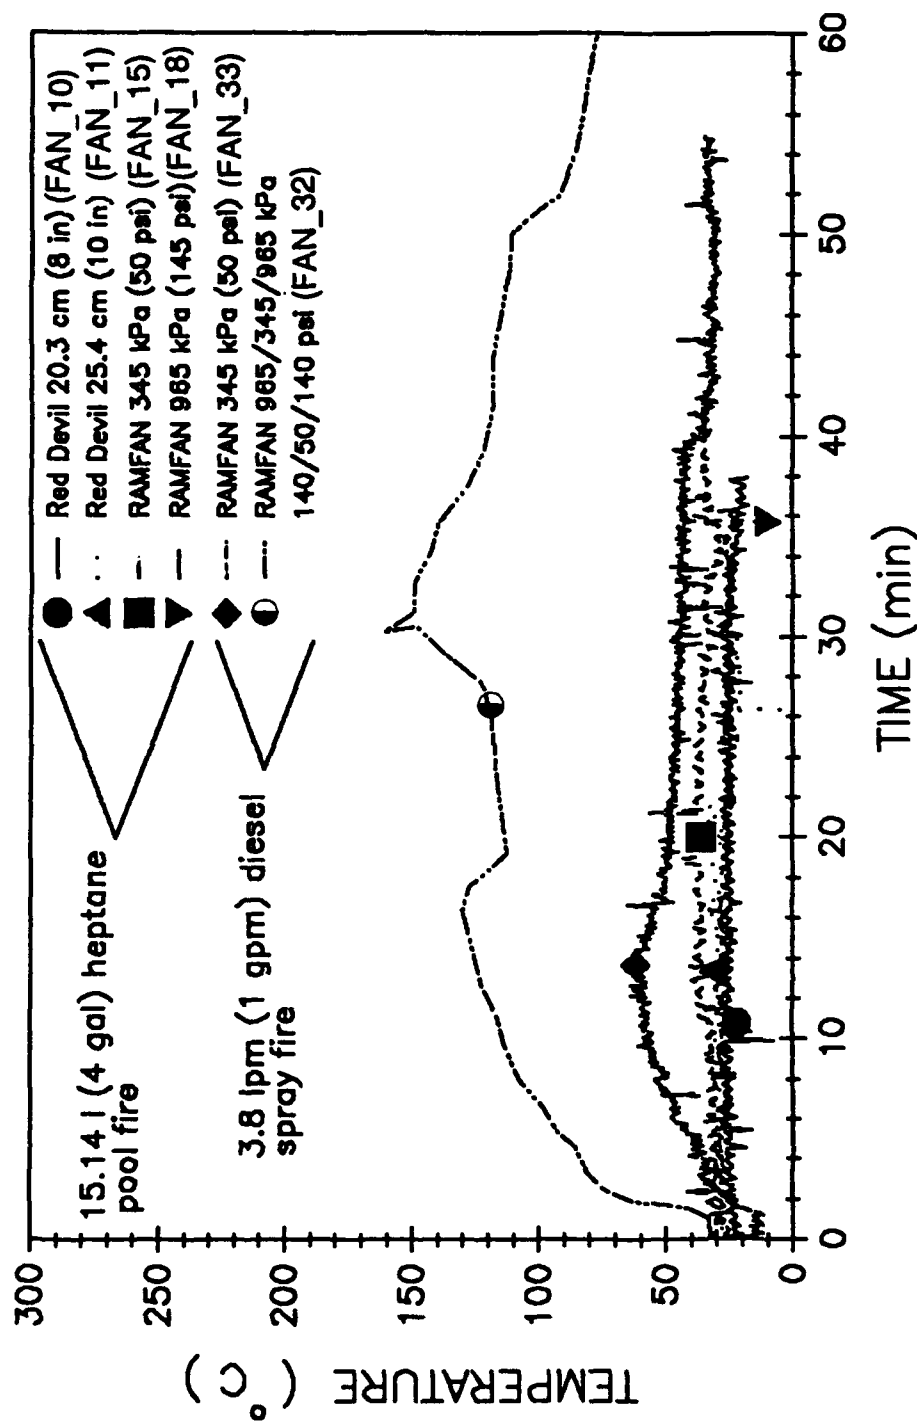
Fig. 100 - Inlet duct temperature after fan is activated

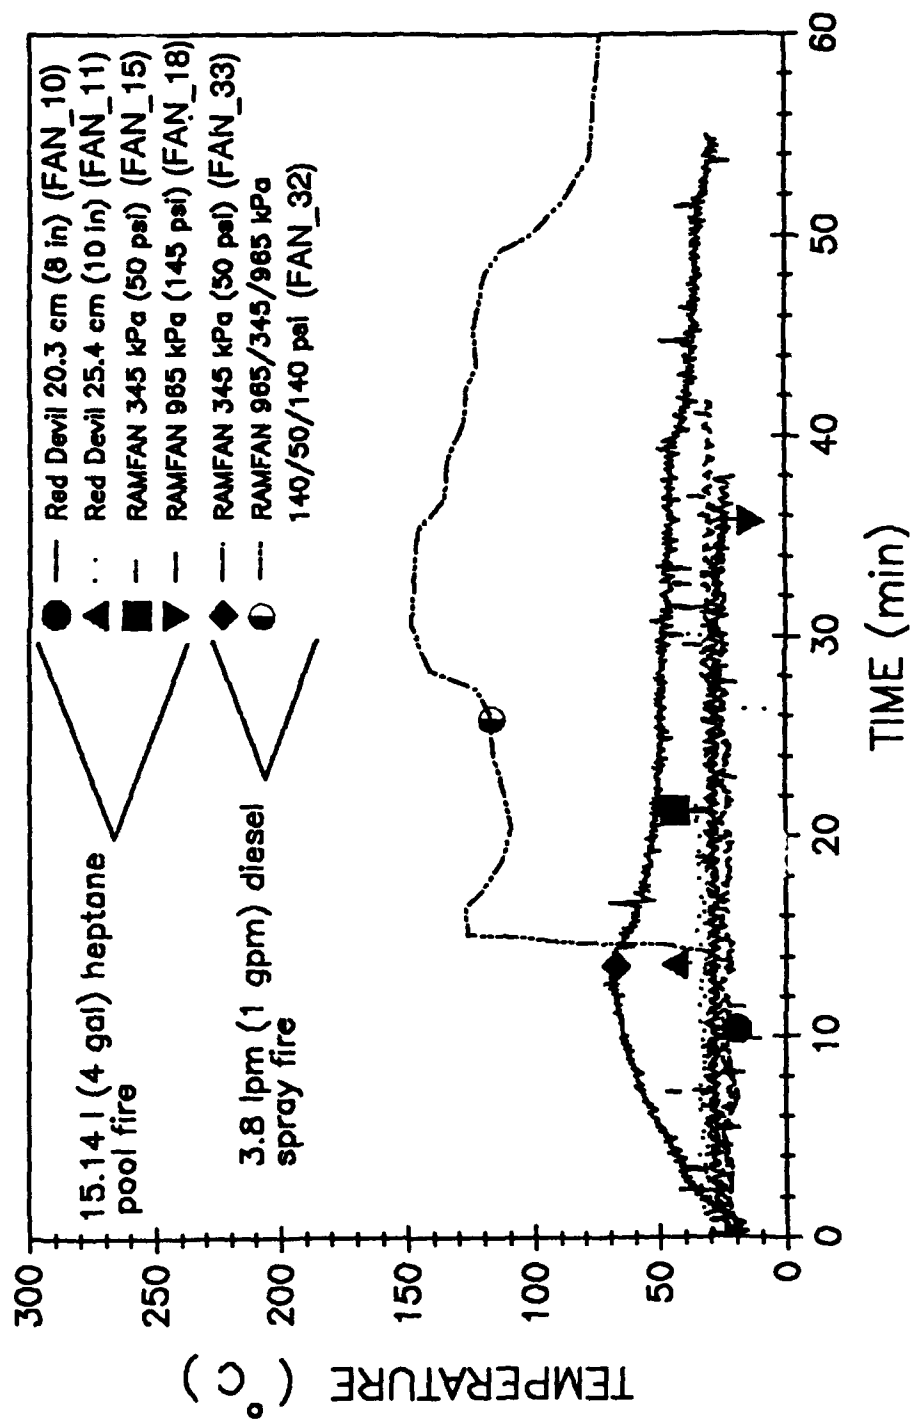
Fig. 101 - Inlet fan temperature after fan is activated

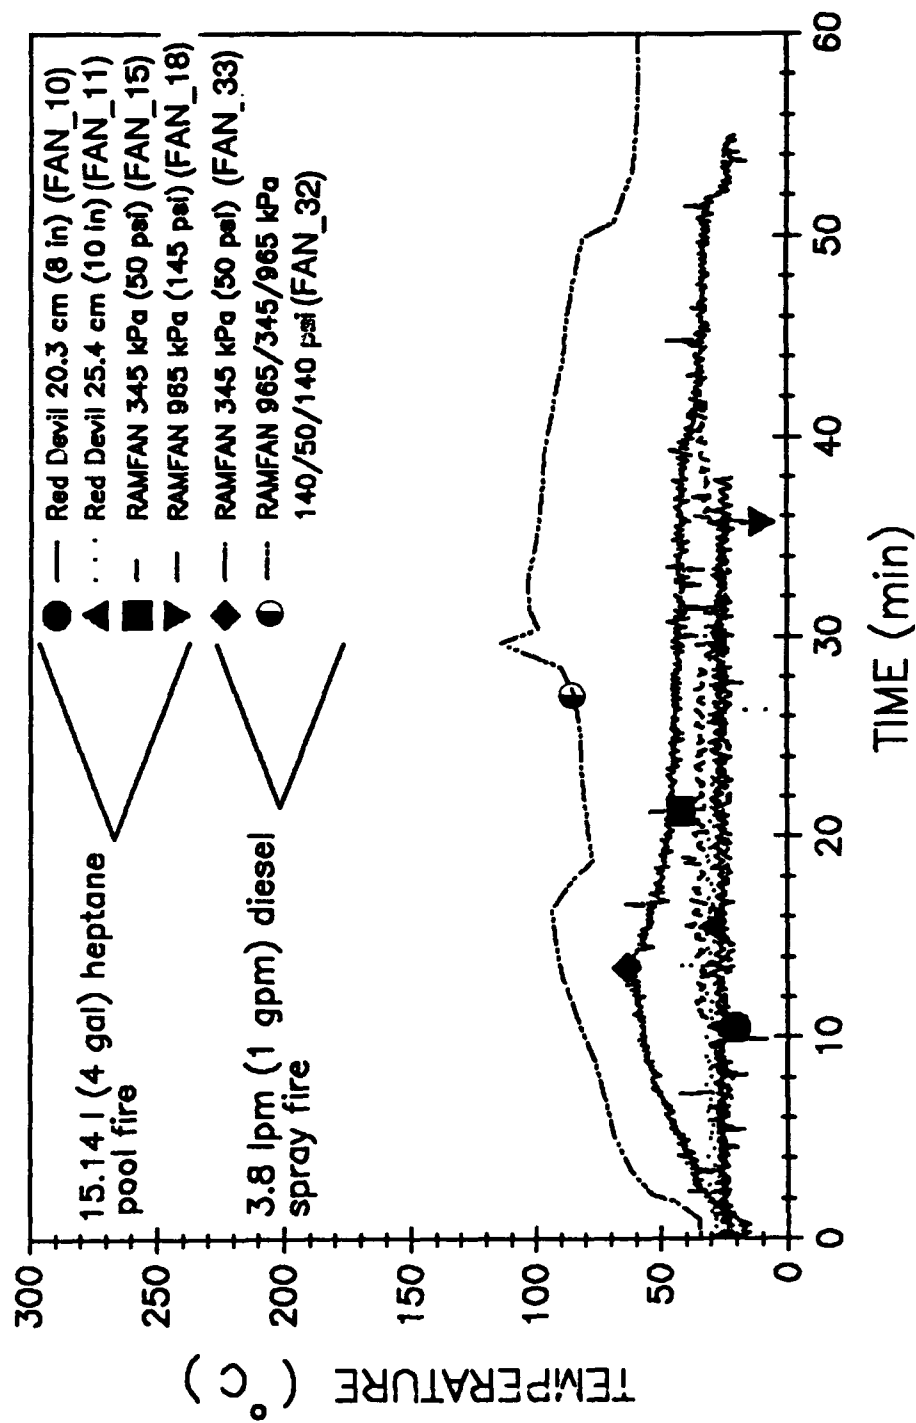
Fig. 102 - Discharge duct temperature after fan is activated

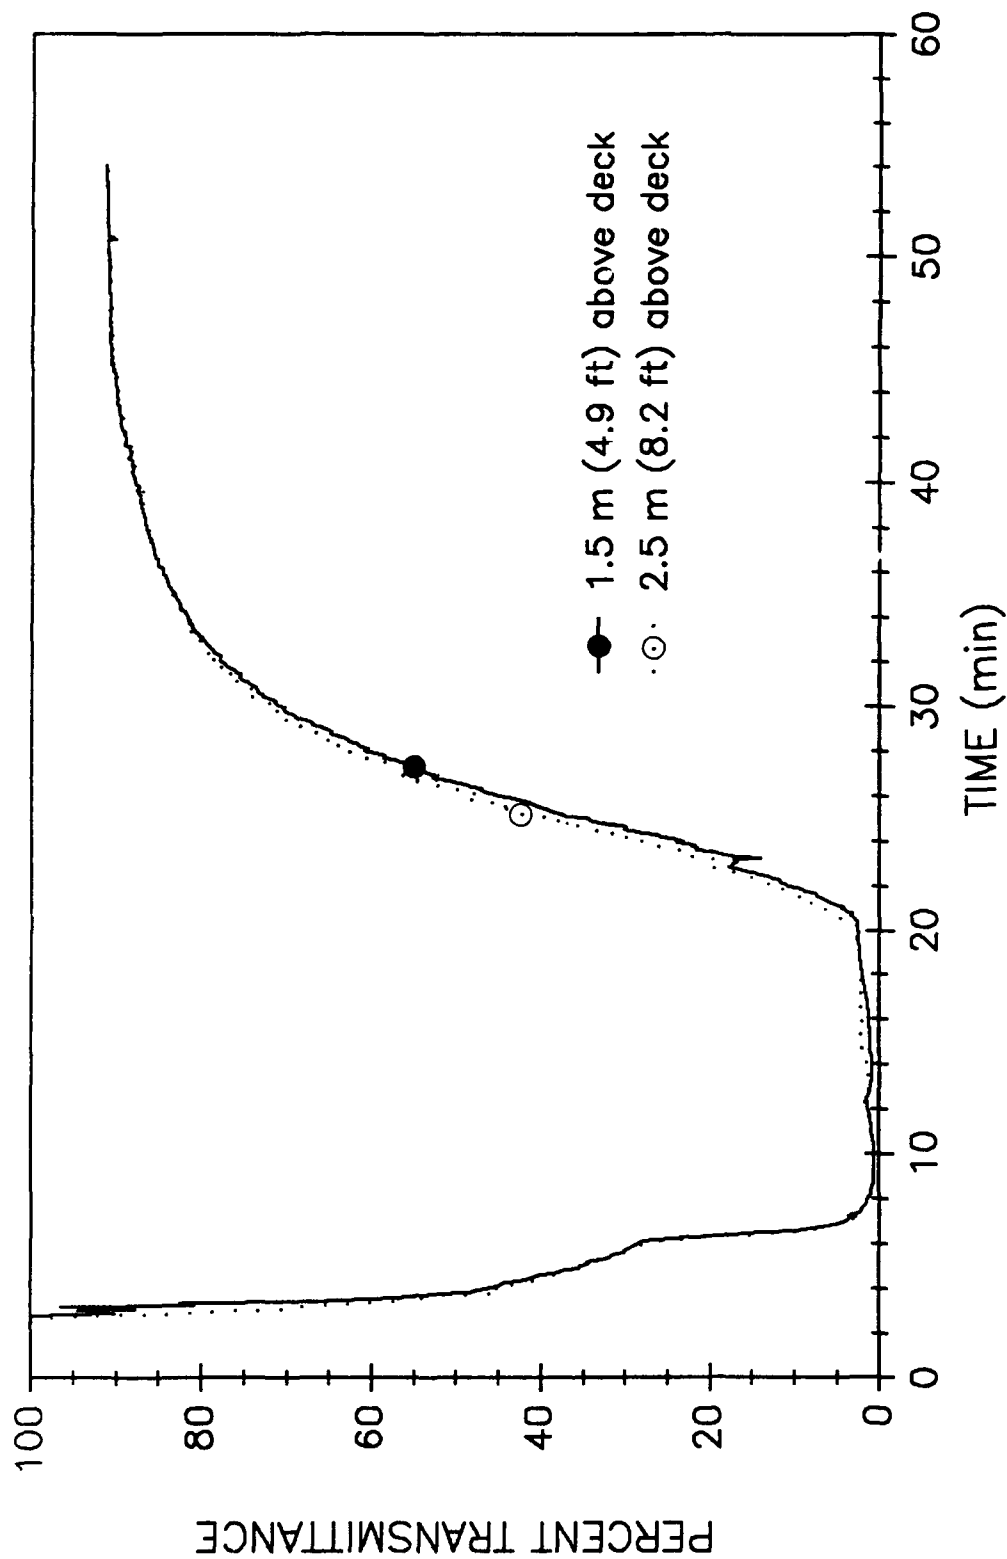
Fig. 103 - Percent transmittance in RICER 1 during FAN\_24  
using RAMFAN 992 kPa (144 psi)
